## FOR SALE GP38M Locomotive #3842

# LOCOMOTIVE INSPECTION REPORT

## #3842 Inspection Report (Cont.)

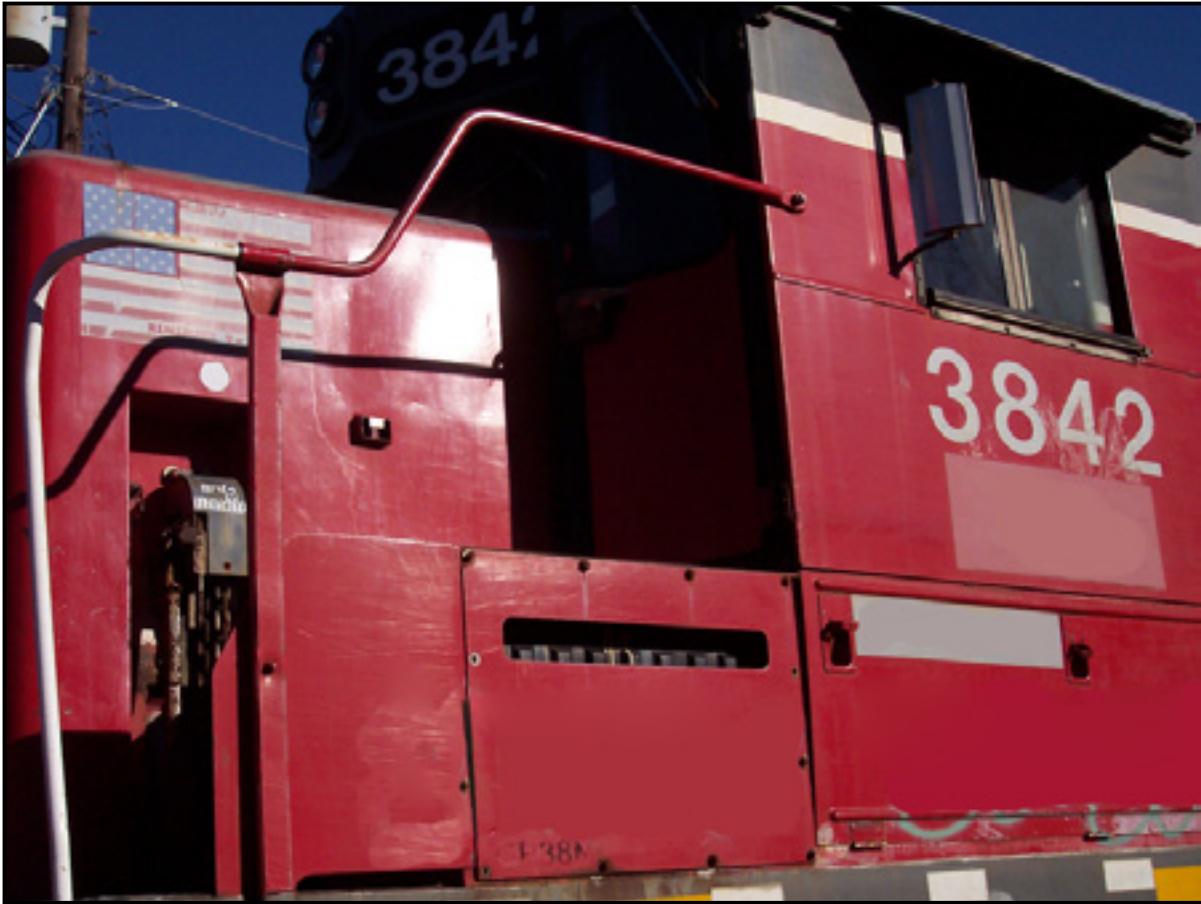
### #3842 Wheelsheet

| Left Rim Thickness | Left flange Thickness | Left Flange Height | Left Rim Whtness G. | Right Rim Thickness | Right Flange Thickness | Right Flange Height | Right Rim Whtness G. |
| 48 | 20 | 21 | 41 | 48 | 17 | 22 | 40 |
| 51 | 20 | 18 | 42 | 52 | 20 | 18 | 42 |
| 48 | 20 | 20 | 41 | 46 | 15 | 22 | 39 |
| 46 | 20 | 20 | 37 | 47 | 20 | 20 | 37 |

- Looks like most of the air equip. is there for shipping.
- #3 wheel has a 15/16 flange thickness. it will need to be cut.
- The rear coupler assy., Pin and retainer with cotter key are missing.
- Axle alt. missing.
- Control stand both air gages are missing.
