## FOR SALE GP38M Locomotive #3842

# LOCOMOTIVE INSPECTION REPORT

## #3842 Inspection Report (Cont.)

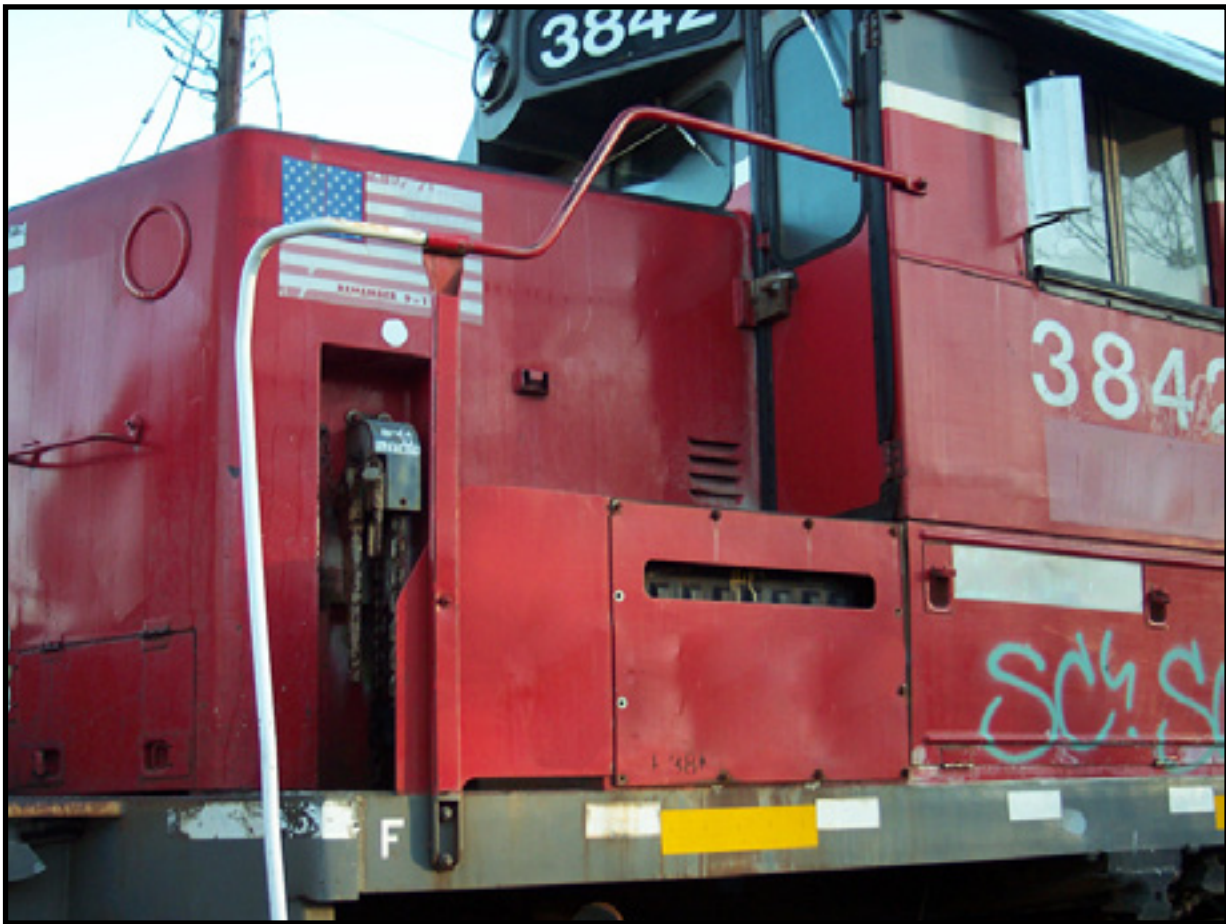
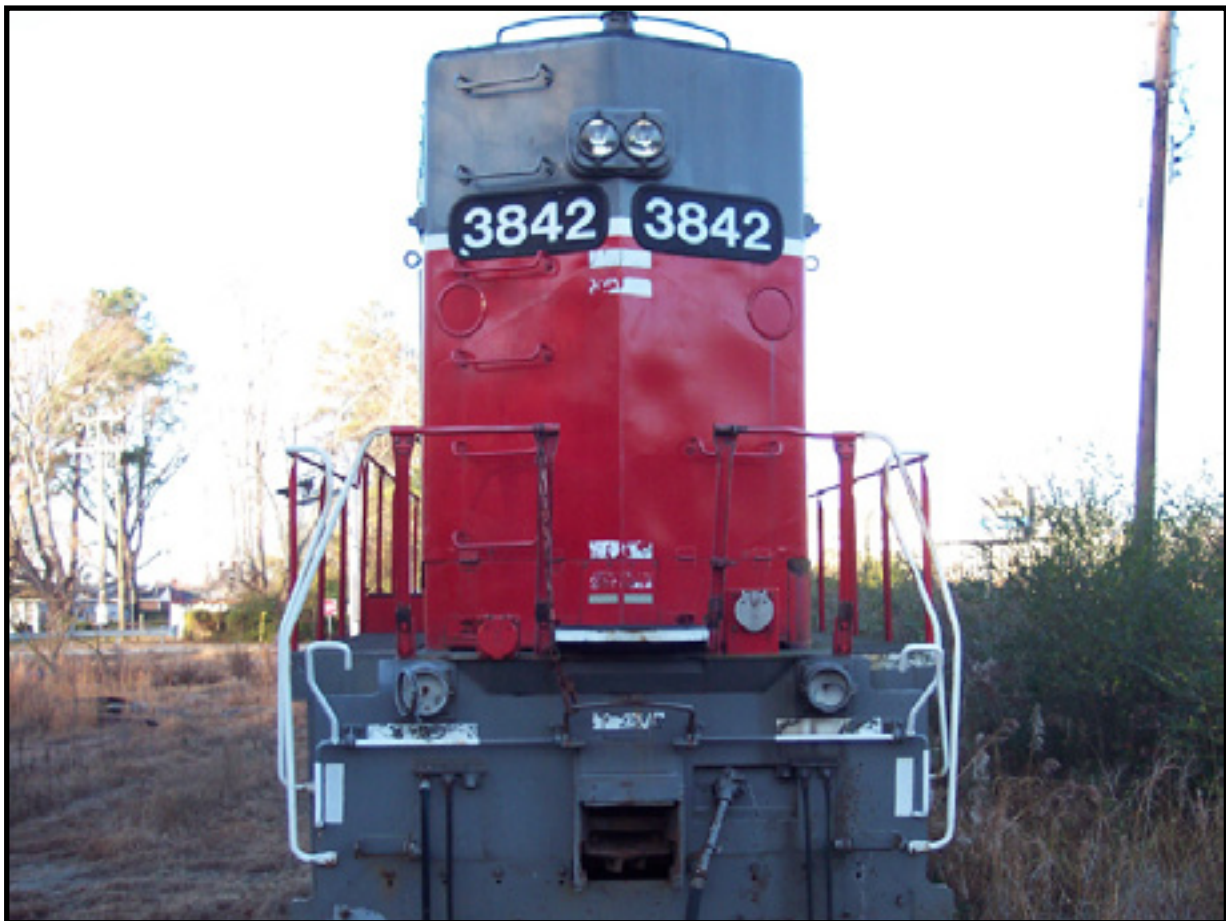
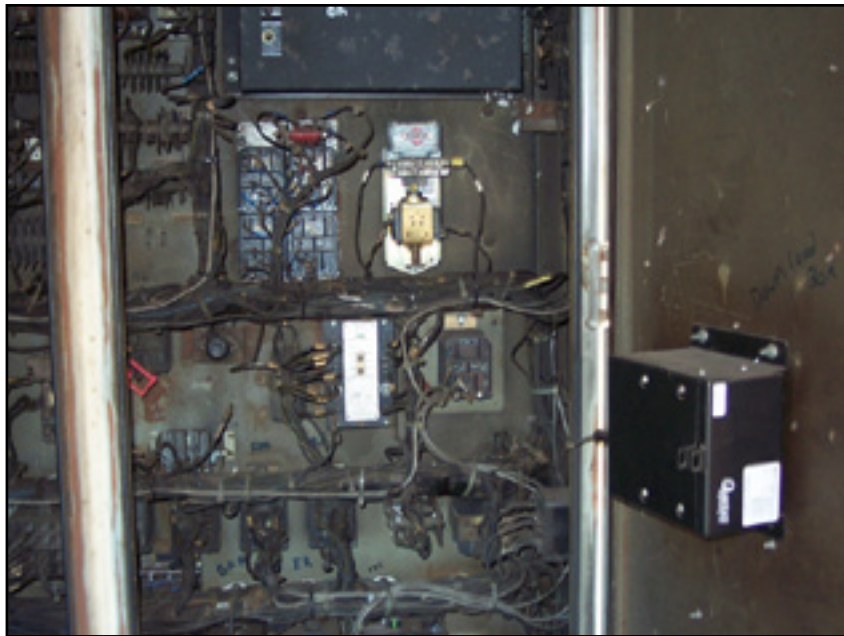
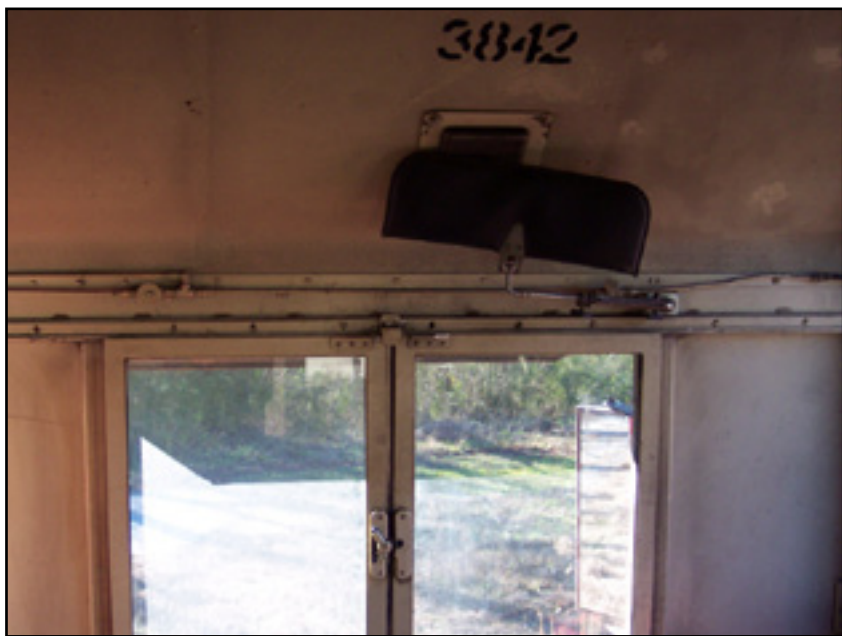
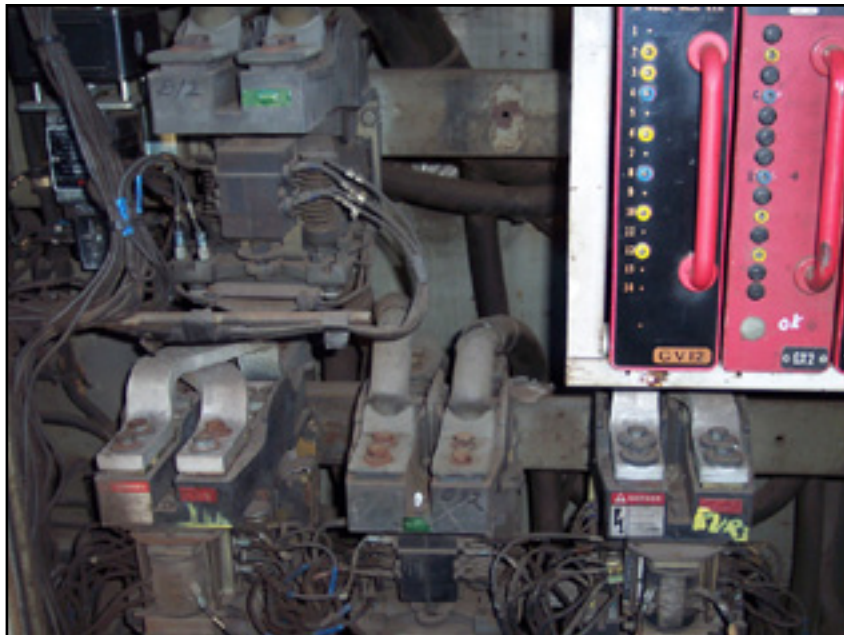
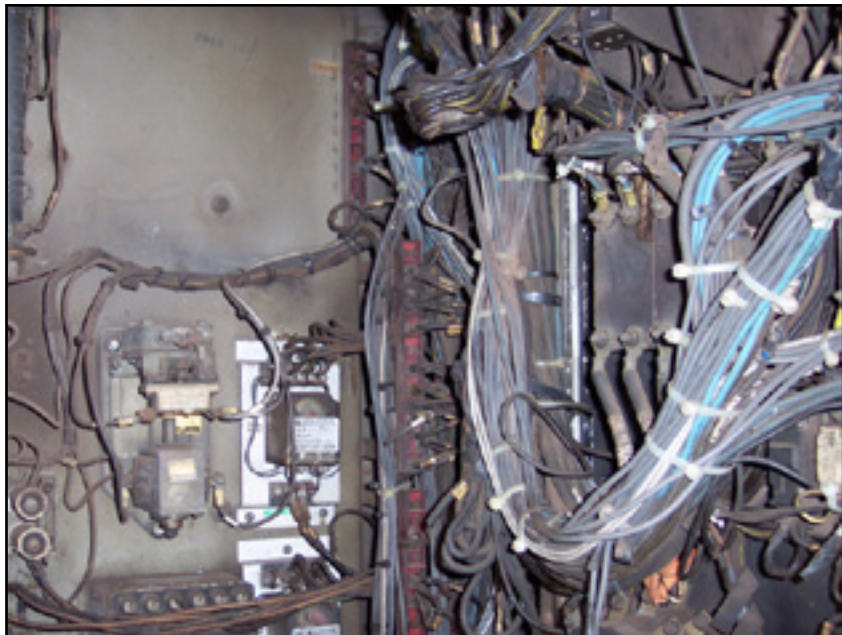
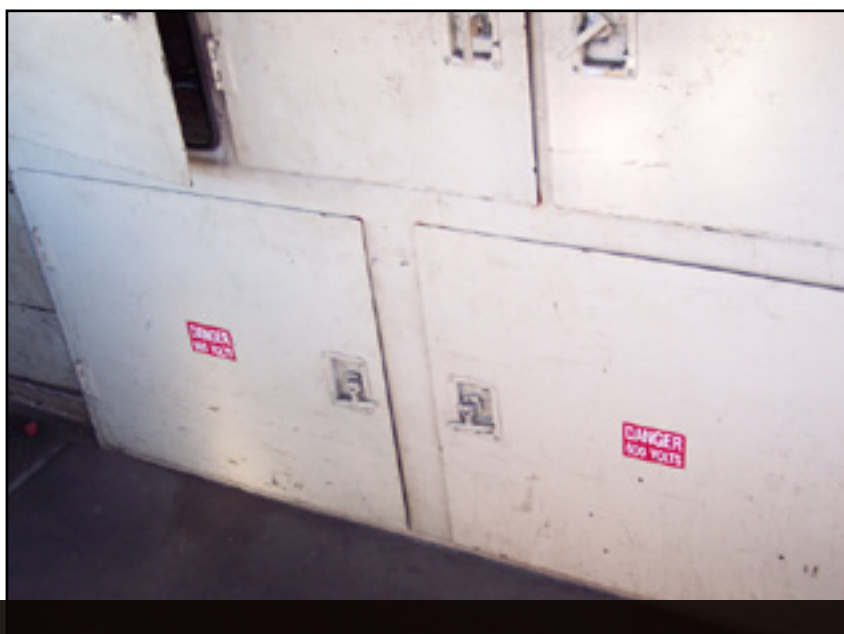
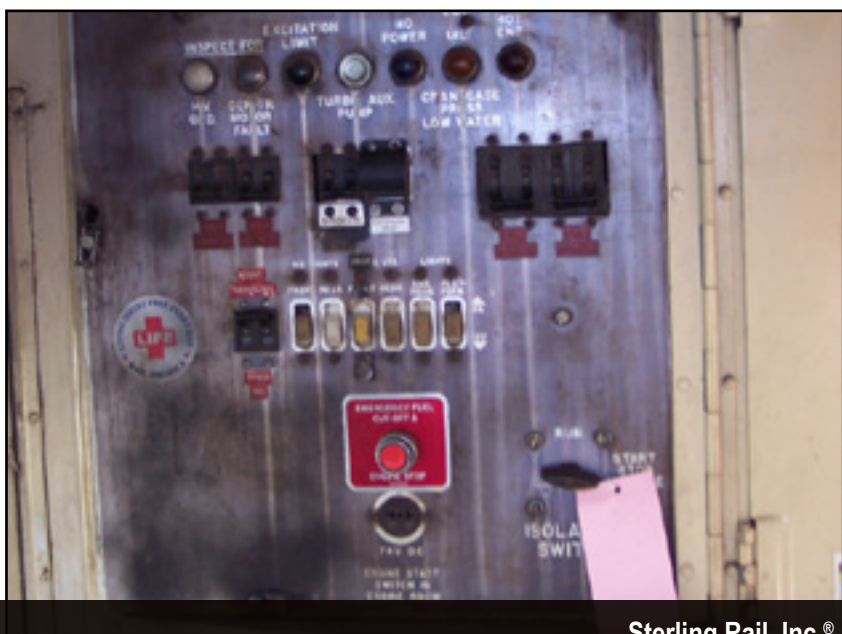
- Looks like most of the air equip. is there for shipping.
- #3 wheel has a 15/16 flange thickness. it will need to be cut.
- The rear coupler assy., Pin and retainer with cotter key are missing.
- Axle alt. missing.
- Control stand both air gages are missing.
