# GP 40 Locomotive #4502

## Inspection Report

## **WORK SCOPE FOR IDAHO NORTHERN & PACIFIC LOCOMOTIVES**

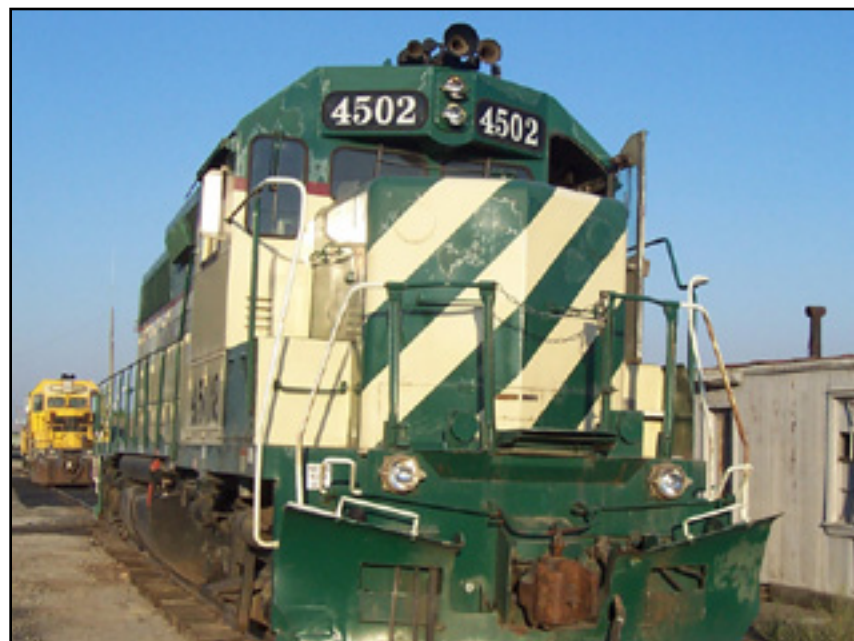
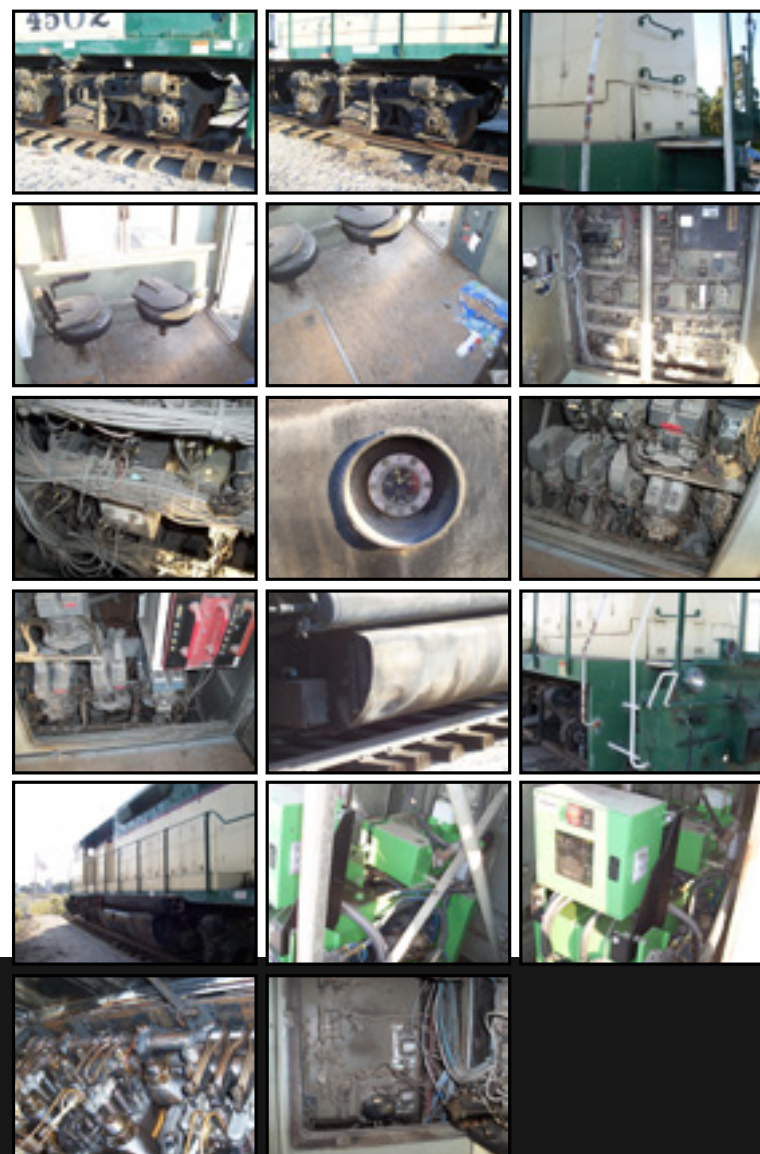
- Car body is in good shape –Left rear sand trap door hinges bad
- Clear coat peeling off
- Cab has raw plywood flooring
- One broken side windows
- Electrical cabinet has been NOT rewired and needs help, but this unit was running in service 8 months ago (poor operational)

- No missing parts
- Dynamic Brake tagged not working
- Unit has traction motor cut outs, No self load
- The control stand has nothing missing
- Batteries have 59 volts and are grounded, very dirty and corroding --- new 12-07

- AR10 looks to be in good shape
- Engine looks to be shut down running and top deck and air box are not as dirty as others
- No large oil leaks could be seen, engine air filters very dirty

- No Crankcase damage
- AC cabinet needs some help with wiring and cleaning noting missing
- Unit has deep sump G.D WBO air compressor no defects noted
- This unit has EC Trans Technologies APU diesel powered very nice unit new 2006

- Radiators have no visual signs of leaks, they need to be pressure washed. Fans all turn freely
- Dynamic Brake grids burnt up (3) and fan turns freely

- Trucks look ok will need some brake shoes replaced before shipping
- Wheels all new 2008
- Unit has self aligning couplers
- Horn and crossing bell in place

- Stack NOT covered
- 10 KW aux gen
- Engine serial # 63-G- 44 R 16-567-D3A had all new 645 power packs in 2008
- Turbocharger serial # MKC 96/03/710962P
